WILLOUGHBY CREEK BRIDGE REPAIR

In September, 2011, Jefferson County Public Works completed repairs to the Willoughby Creek Bridge on the Upper Hoh Road in West Jefferson County.

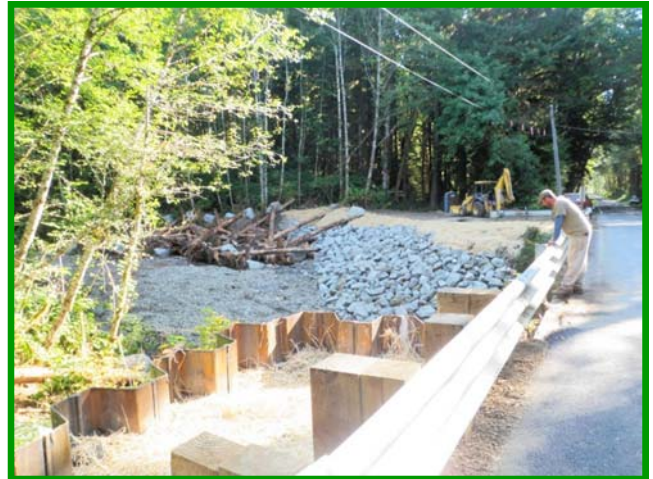
This view of Willoughby Creek Bridge shows many elements of the project — new sheet pile wall (foreground), and stream bank armoring and engineered logjams (background).

Flooding in January, 2009, severely eroded the stream bank threatening the roadway at both ends of the bridge. Repairs consisted of constructing a sheet pile retaining wall at the west end of the bridge and repairing stream bank armoring underneath and upstream of the bridge. Engineered logjams were also constructed upstream of the Willoughby Creek Bridge as additional stream bank protection. The work was completed by Seton Construction of Port Townsend.

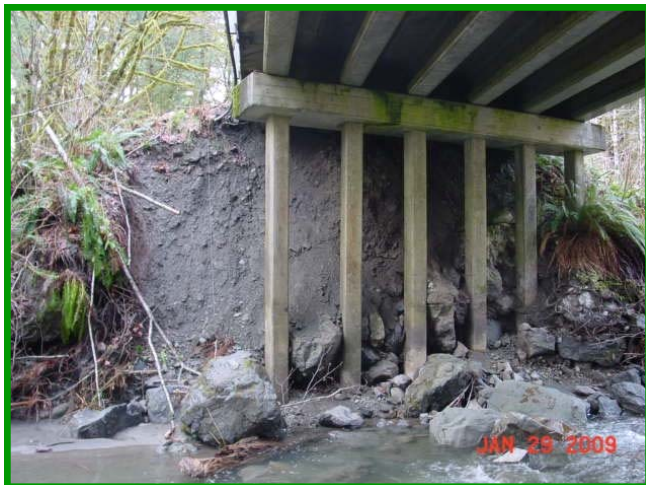
A view under the bridge before the repair project reveals severe erosion caused by flooding in 2009.
